AAF Technical Report 5230

ATSC COLD WEATHER TESTS WINTER 1944-1945

Report No. 5230
Date: 31 May 1945

ARMY AIR FORCES TECHNICAL REPORT
No. 5230

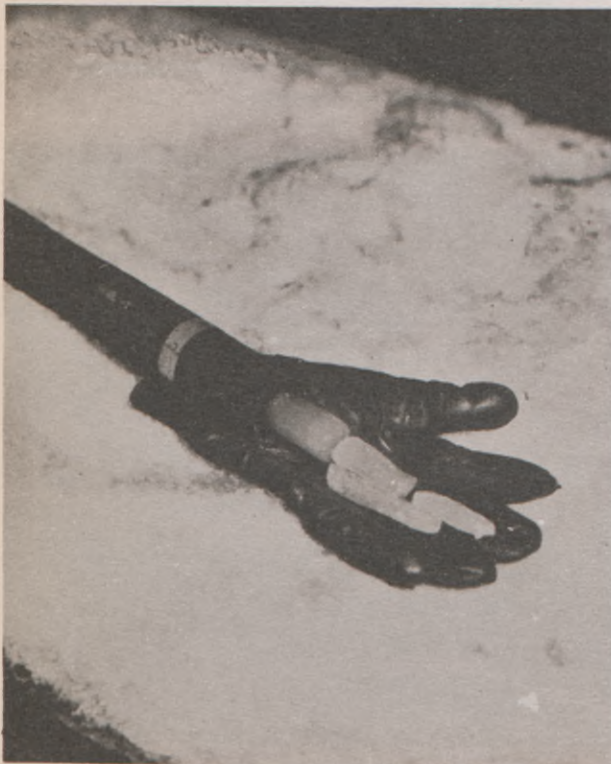
Ice found in fuel inlet line

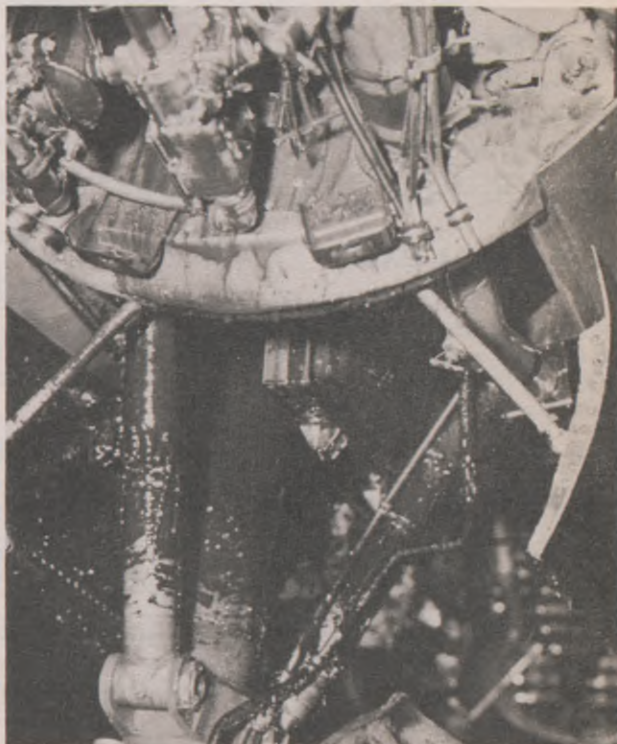
Result of oil spewing

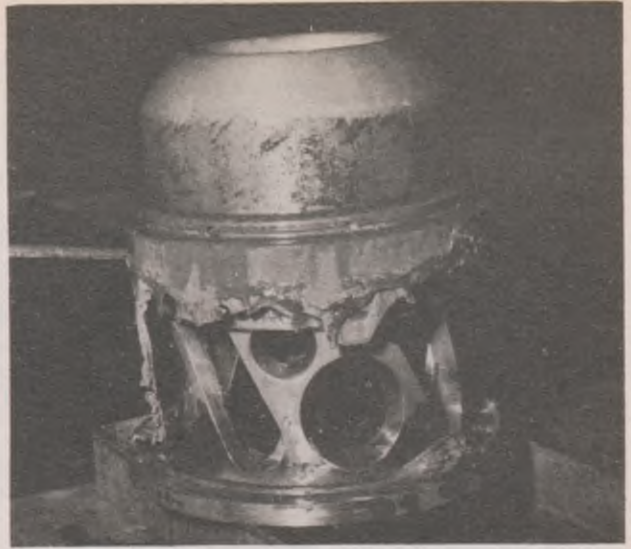
Sludge deposited in propeller dome from synthetic engine oil

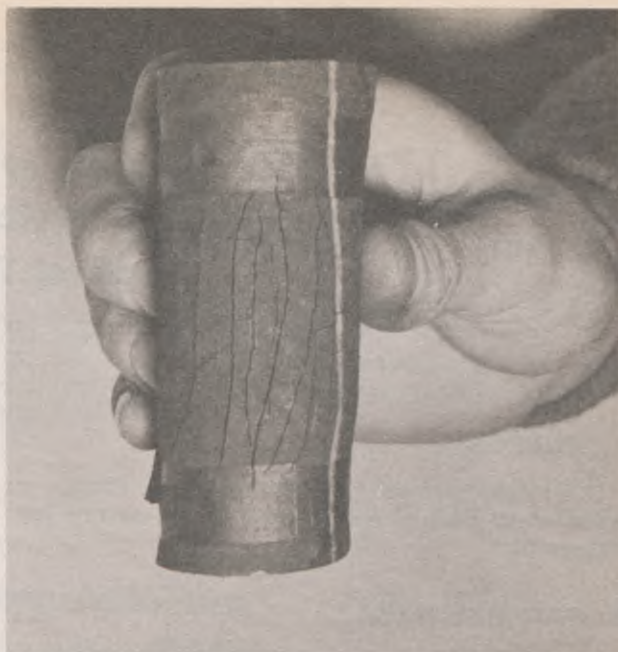
Numerous methods to facilitate hose application over the nipples were used. It was found that all hose could be applied readily by using a lubricant of oil. However, it is believed that this method creates a problem inasmuch as maintenance personnel may be prone to use oil as an aid to installation on self sealing hose. Again, it is felt that an oil lubricant may at some time cause a slipping action to take place between the tube and the nipple and during a cold start or semi-cold start act as the impetus in allowing a connection to blow loose.

Outer covering cracked on aromatic resistant oil hose

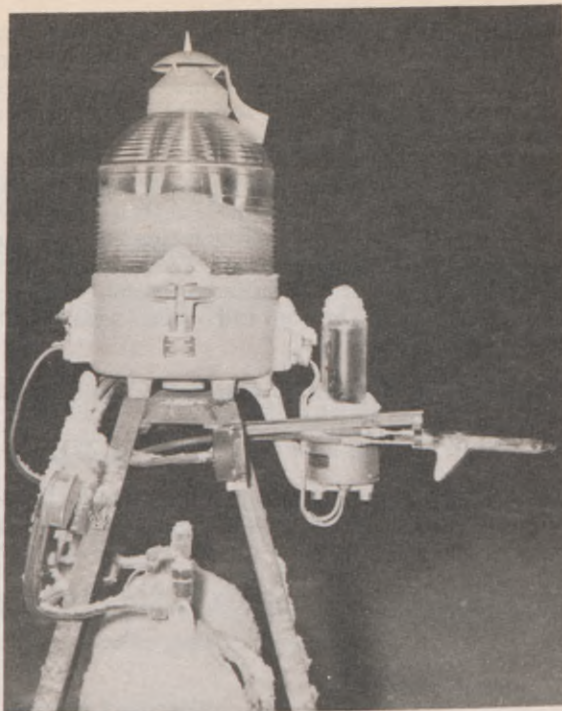
Frost accumulation inside Fresnel lens

1. The lamp assembly, if provided with a means for preventing frost accumulation on the Fresnel lens, such as that mentioned in Par. B.5, will be entirely satisfactory

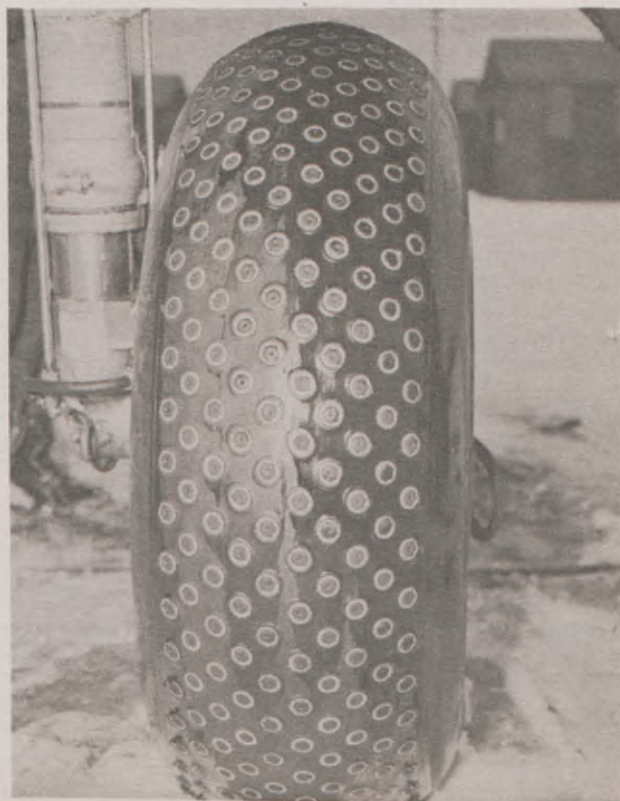
Ice grip tire with steel bottle-cap inserts after 67 landings

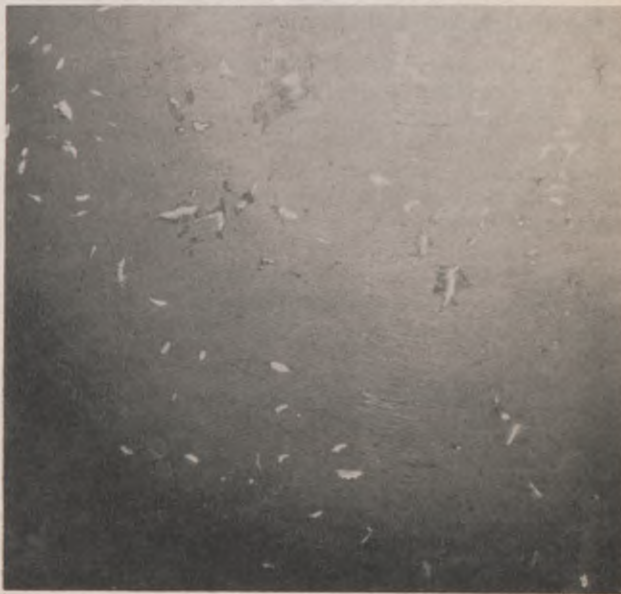
B-29 Radar dome damaged by ejected shell cases. Low temperatures caused embrittlement of dome

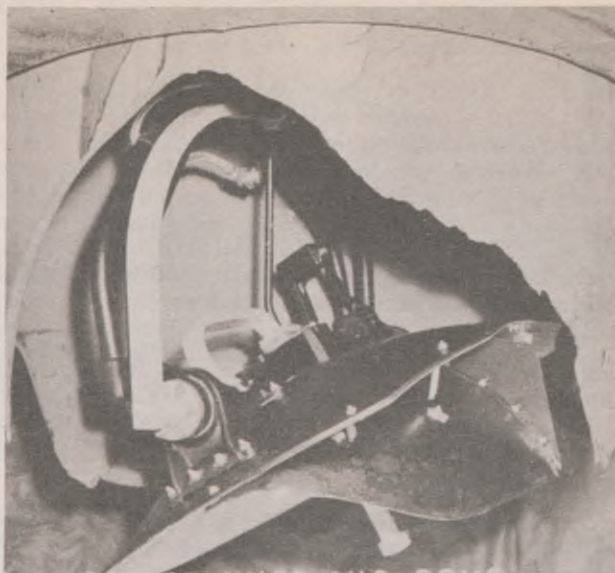
Airflow type radome damaged by ejected shell cases
