AAF Technical Report 5230

ATSC COLD WEATHER TESTS WINTER 1944-1945

Report No. 5230
Date: 31 May 1945

ARMY AIR FORCES TECHNICAL REPORT
No. 5230

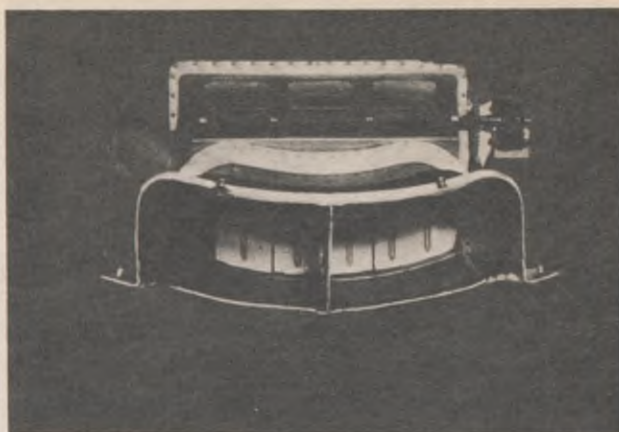
1. This type carburetor heat system was installed on the No. 2 engine of Air Technical Service Command cold weather test airplane B-24J Serial No. 44-41378. The duct ahead of the intercooler on the No. 2 engine was reworked and was provided with two sets of gates one located at the front end of the duct, Figure 1, and the other on the accessory section side of the duct, Figure 2, so that with heat ON the intercooler intake air would be cut off ahead of the intercooler and warm air from the accessory section would be allowed to flow through the intercooler. The gates were operated by an electric motor through gear segments. The intercooler shutters on this engine were disconnected from the drive motor and safetied open, and the wiring was rerouted and connected to the motor which drove the carburetor heat gates. In order to allow control of the carburetor heat gates a momentary contact type switch was installed

B-24 Intercooler Duct—Front Gate

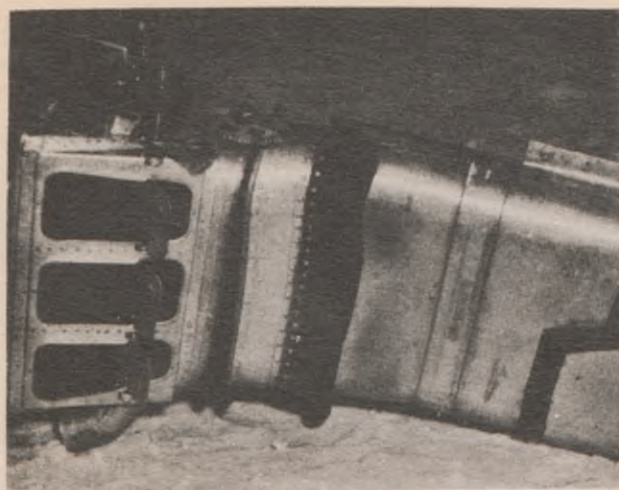
B-24 Intercooler Duct—Accessory Section Gate

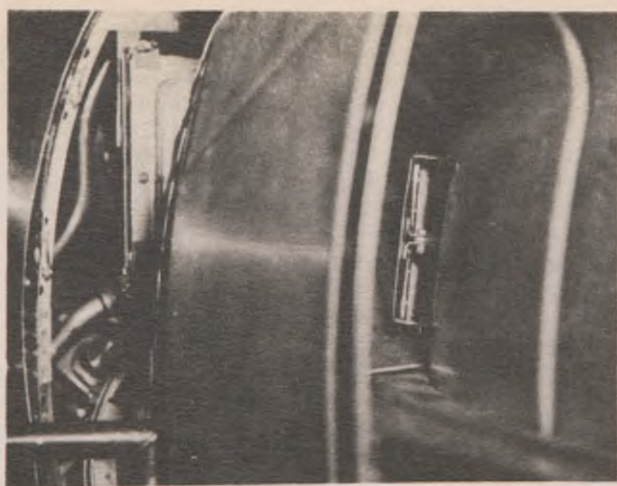
B-24 Accessory Section Pressurizing Scoop

3. The test on the accessory section carburetor heat system wherein the pressurizing scoop was actuated revealed that opening of this scoop failed to increase the carburetor air temperature over that available with the pressurizing scoop closed. In fact allowing the scoop to remain open with carburetor heat ON tended to cause a slight decrease in the carburetor air temperature. The results of this test were plotted in Figure 2 from Table II, Appendix III.

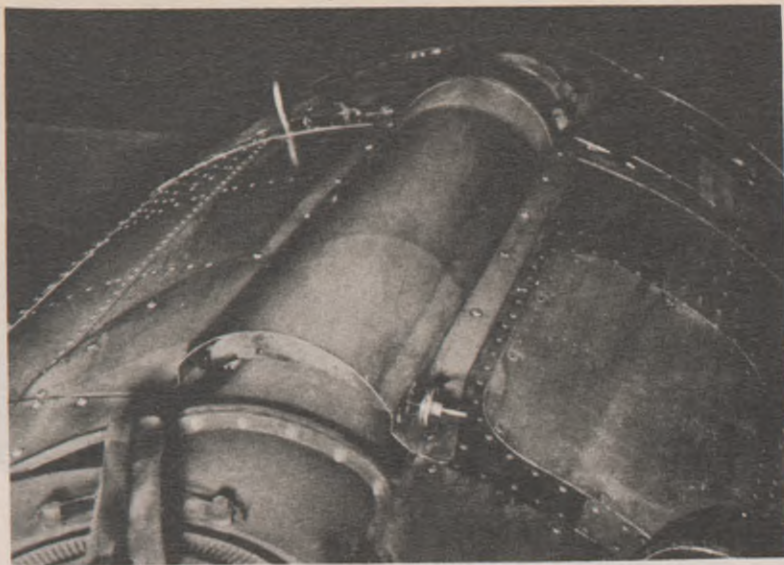
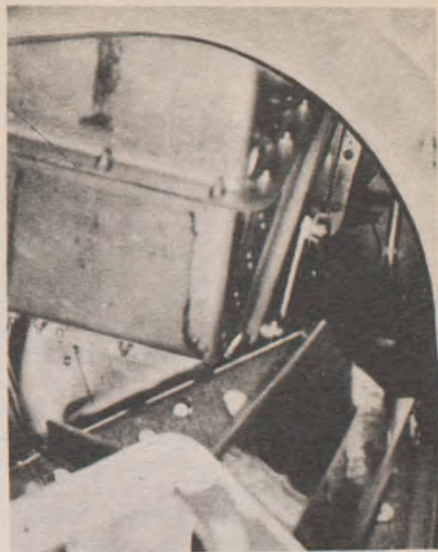
1. An exhaust manifold type carburetor heat system was installed on the No. 1 engine of Air Technical Service Command cold weather test airplane B-17G Serial No. 43-38221. It consisted of a stainless steel shroud around the exhaust manifold, Figure 4, from which hot air was ducted from the right rear side of the upper shroud to the induction system below the air filter by means of a $4\frac{1}{4}$ inch I.D. flexible aluminum tubing wrapped with strip asbestos as shown in Figure 5. Since the hot air duct was tapped into the induction system ahead of the air filter valve as shown in Figure 6, turning the air filter ON on this engine allowed flow of hot air instead of filtered air. A gate was provided at the rear of the shroud to minimize as much as possible the loss of heat and hot air from the carburetor heat shroud. This gate was actuated through a pulley system from the air filter valve motor, as shown schematically in Figure 7, in such manner that it closed when carburetor heat was

B-17 Exhaust Manifold Shroud

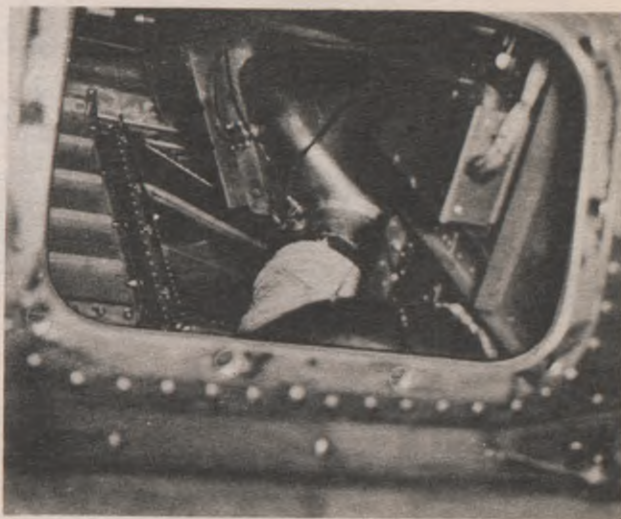
B-17 Carburetor Heat System Ducting

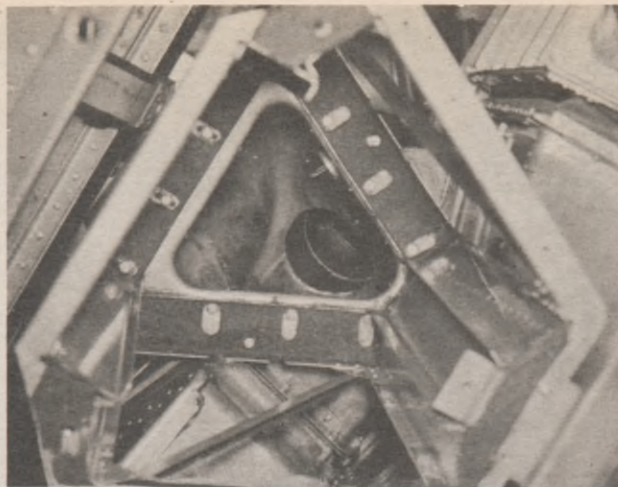
B-17 Filtered and Hot Air Intake

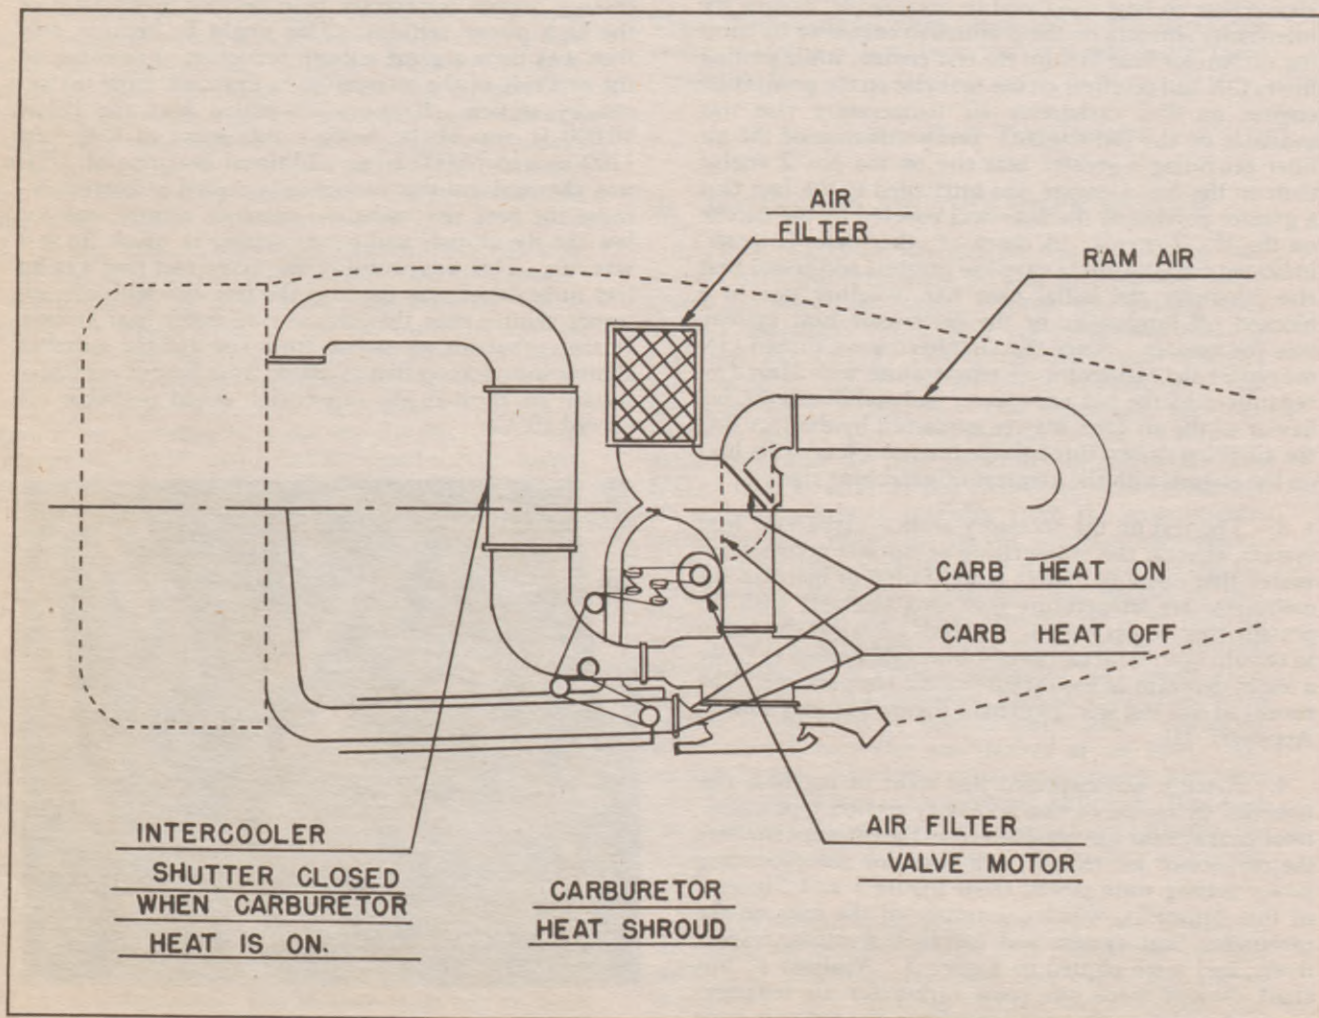
Schematic Diagram of Shroud Gate Pulley Control System

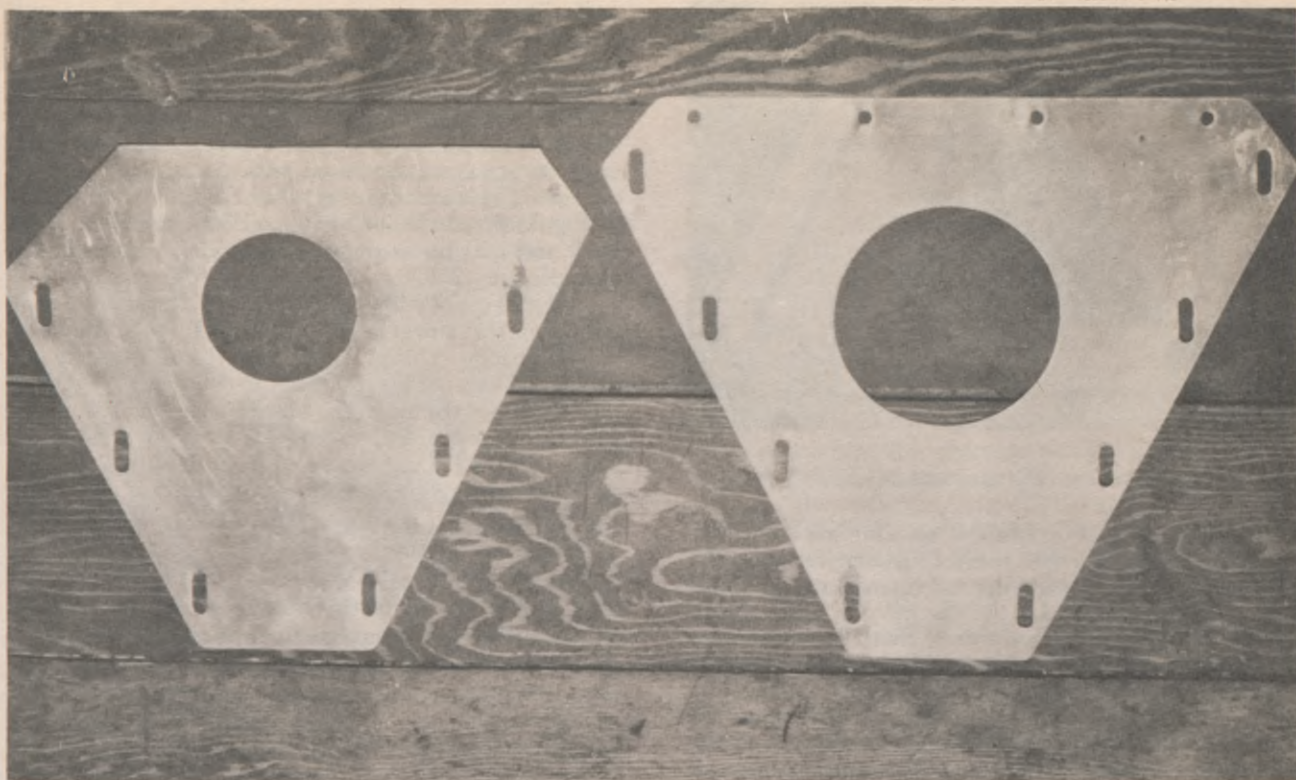
B-17 Air Filter Restrictor Plates

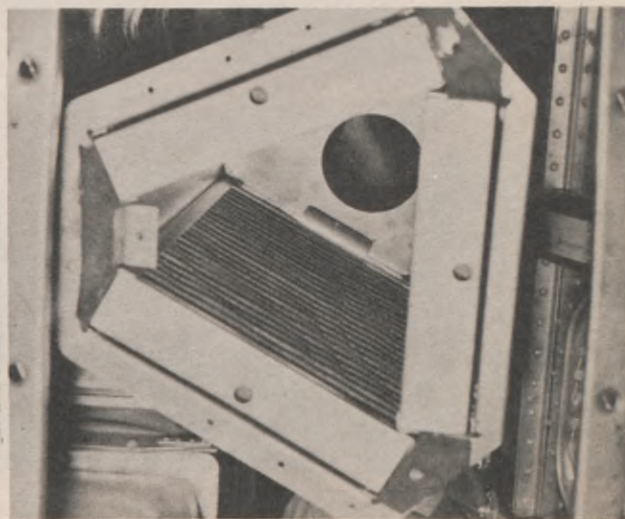
Air Filter Restrictor Plate installed (4" orifice)

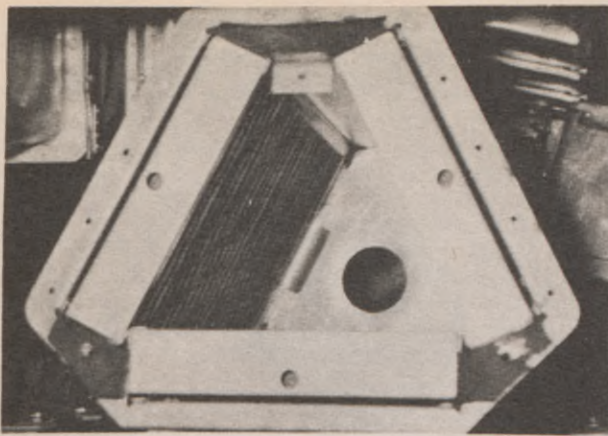
2. The next best arrangement of the exhaust manifold carburetor heat system on the B-17G which gave the maximum carburetor air temperature rise and at the same time allowed feeding of the engine with no greater pressure drop than that experienced by turning on the air filters on the production engine installation was that using the plain shroud and the No. 1 (4" diam. orifice) air filter restrictor plate. At 600 hp and 2000 ft. a carburetor air temperature rise of 22°C was available which is only about 44% of that required as compared to the 3°C average heat rise on the production engine which comes to only 6% of meeting requirements described before. As shown in Figure 6 the heat rise available decreased with decrease in power and increased with increase in altitude as might be expected, however, the results of tests No. 1 and 2 plotted in Figures 4 and 5 indicated that at powers less than 600 hp the carburetor air temperature rise tended to increase. Sufficient data to verify this tendency are not available. The carburetor air temperature rise available during the traffic pattern and final approach were each 24°C which were 6°C and 10°C less than the arrangement using the No. 2 (2¾"

diam. orifice) air filter restrictor plate. These heat rises are not considered quite adequate for this condition of flight.

Air Filter Restrictor Plate installed (2 3/4" orifice)

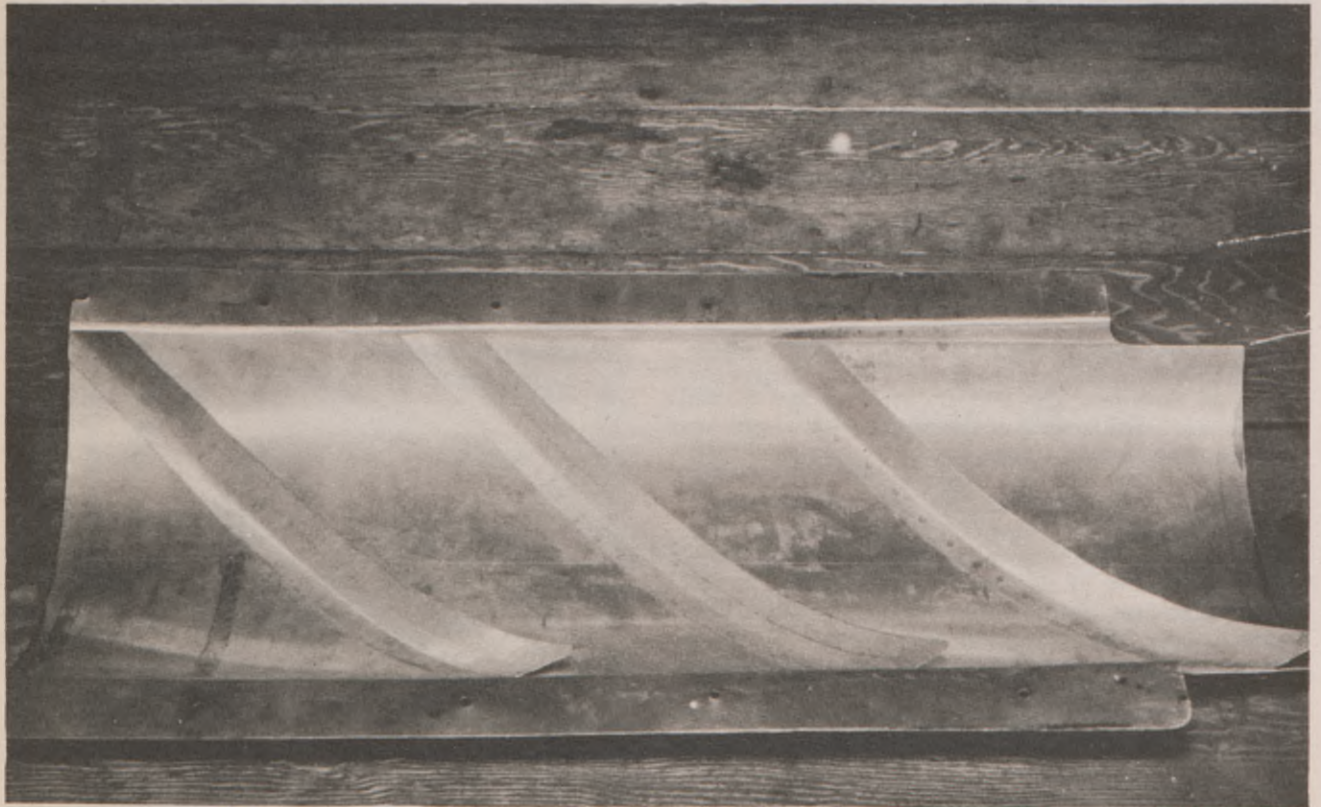
Helical vaned exhaust shroud insert

5. The result of the tests which were run on the helical vaned shroud with varying combinations of the air filter restrictor plates in order to determine its effectiveness in increasing the temperature of the air from this source and consequently increasing the carburetor deck temperature rise were plotted in Figure 6 and temperature surveys for each of these tests are given in Figures 7 to 16 inclusive. Examination of these results show that the helical vaned shroud improved the performance of the carburetor heat system only slightly over that obtained with the plain shroud. The temperature of the air from the hot air duct using the helical vaned shroud was only 5°C to 8°C higher than that using the plain shroud and then only at the low power settings. At high powers the effect of the helical vanes was negligible. This was probably due to the fact that at low powers, because of the lower velocity, of the air flowing through the shroud, the helical vanes were more effective

in inducing a whirling motion in the shroud, and hence increased the time of exposure to the exhaust manifold. Since the use of vanes offered greater restriction to air flow than the plain shroud a greater quantity of air was drawn from the filter to feed the engine, which resulted in a loss of most of the heat gained by means of the vanes. It is believed the weight addition due to use of helical vanes in the shroud is not warranted by the slight additional carburetor heat rise that would be available even in carburetor heat systems where the air from the hot source is not tempered with cold air. Use of a finned exhaust manifold which is worthy of investigation would be of much greater benefit.

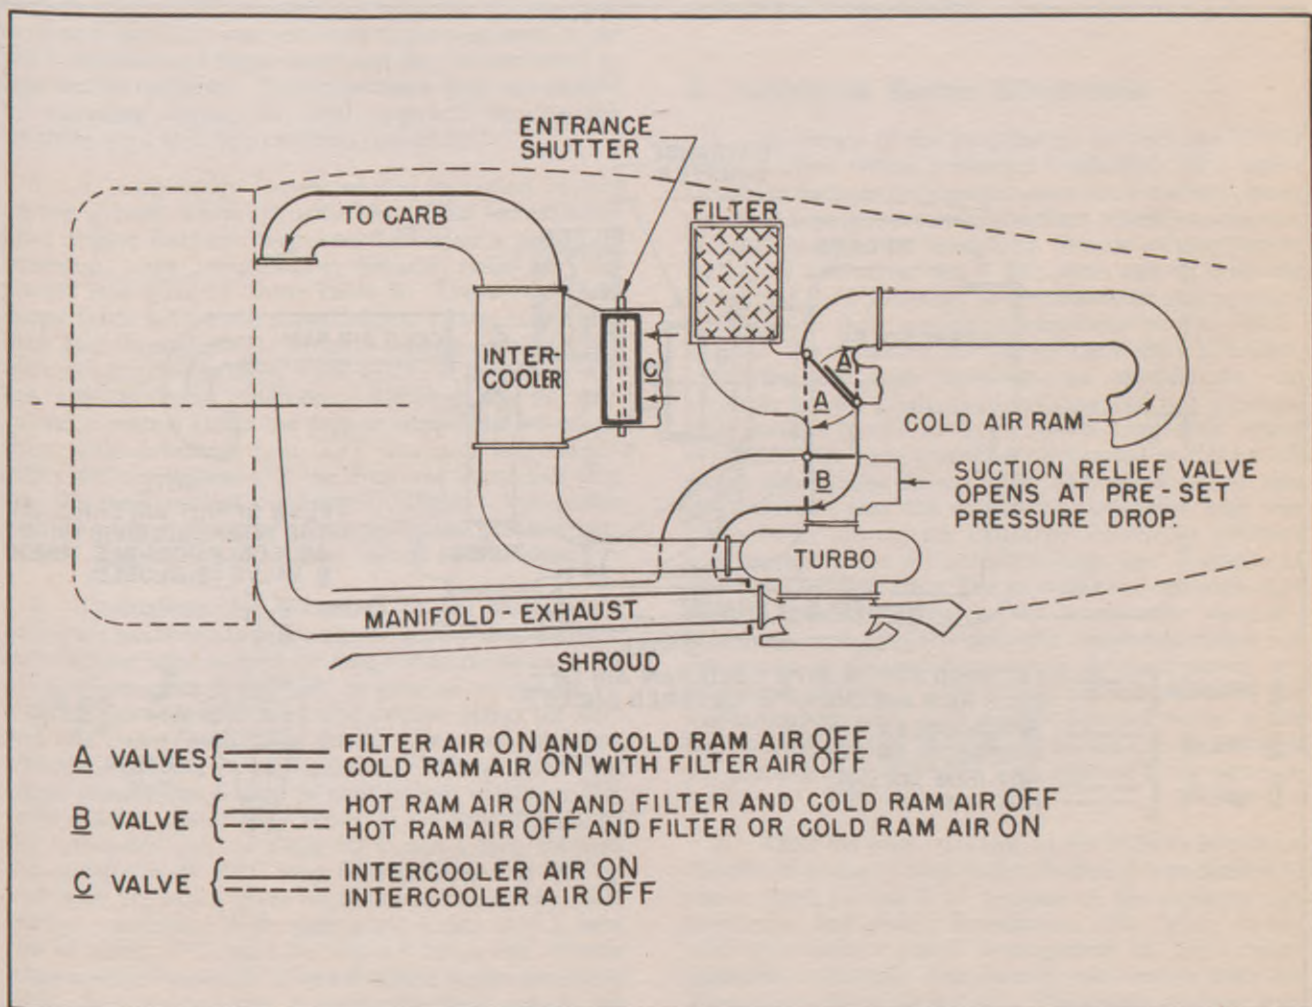
Schematic Diagram of Exhaust Manifold Type Carburetor Heat System

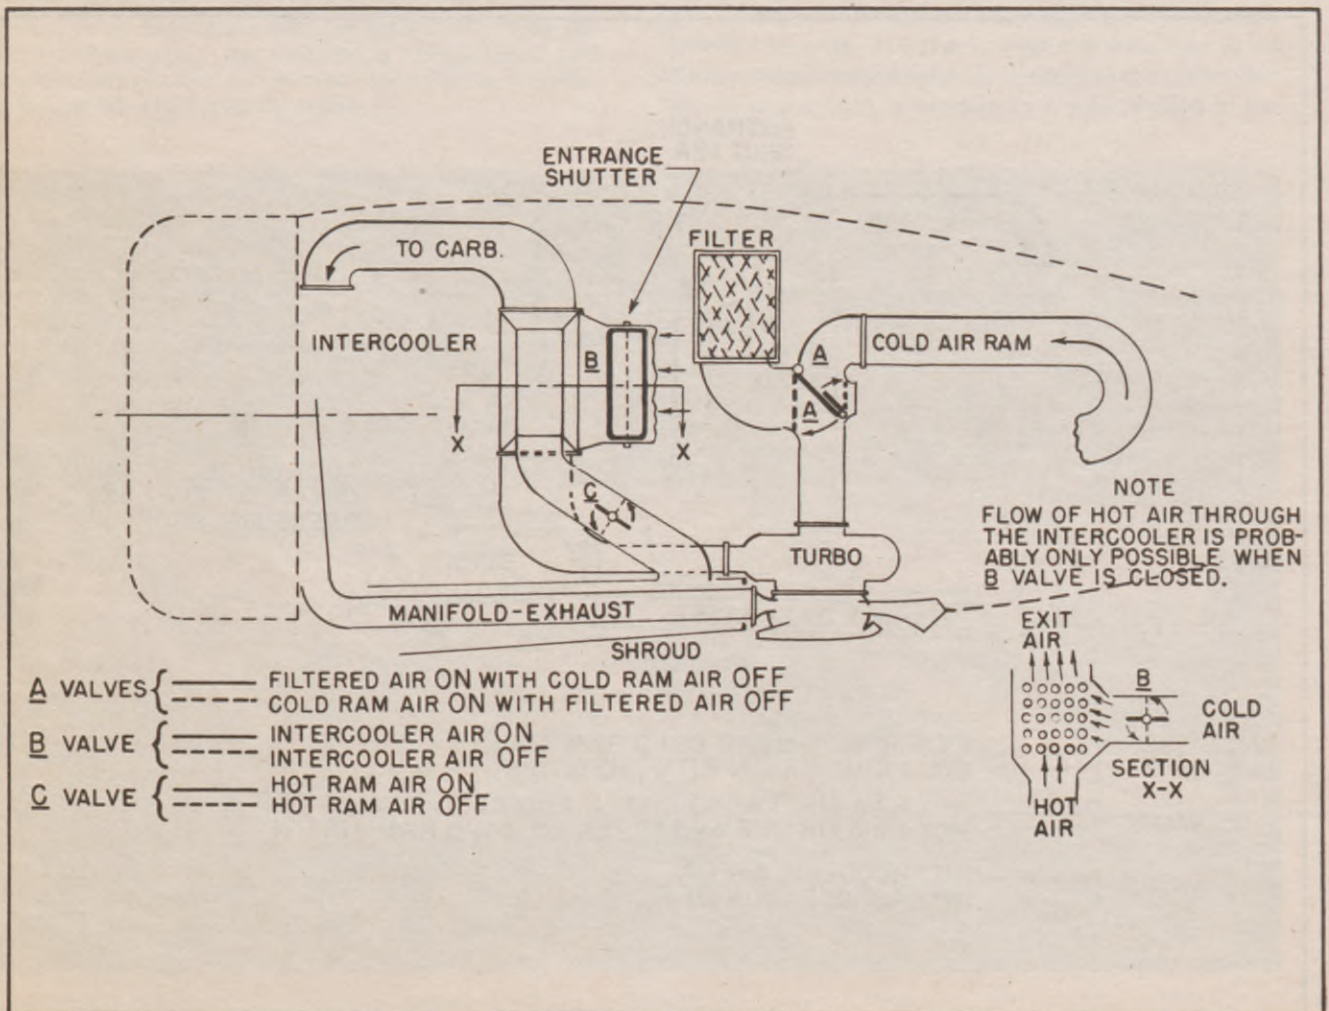
Schematic Diagram of Proposed Inter-Warmer Type Carburetor Heat System

2. Another carburetor heat system which is a development of the accessory section type carburetor heat system tested on a B-24 and discussed in this report is shown in Figure 2. This is merely a proposed system since no data is available on its performance. It consists essentially of ducting hot air from a shroud around the exhaust manifold into the intercooler. Such a system demands the use of entrance type intercooler shutters so that ram air can be closed off ahead of the intercooler and thus will not prevent flow of the hot air. It is believed that the ram effect at the hot air shroud will be sufficient to flow the hot air over the intercooler tubes. The amount of ram and area of ducting which will provide the greatest possible heat transfer to the carburetor air are all factors of design and test which must be determined. It is not known whether or not the rapidity of carburetor heat rise would be sufficient to allow use of this system as a means of combating carburetor ice. It is believed that this system would provide all the heat rise desired at

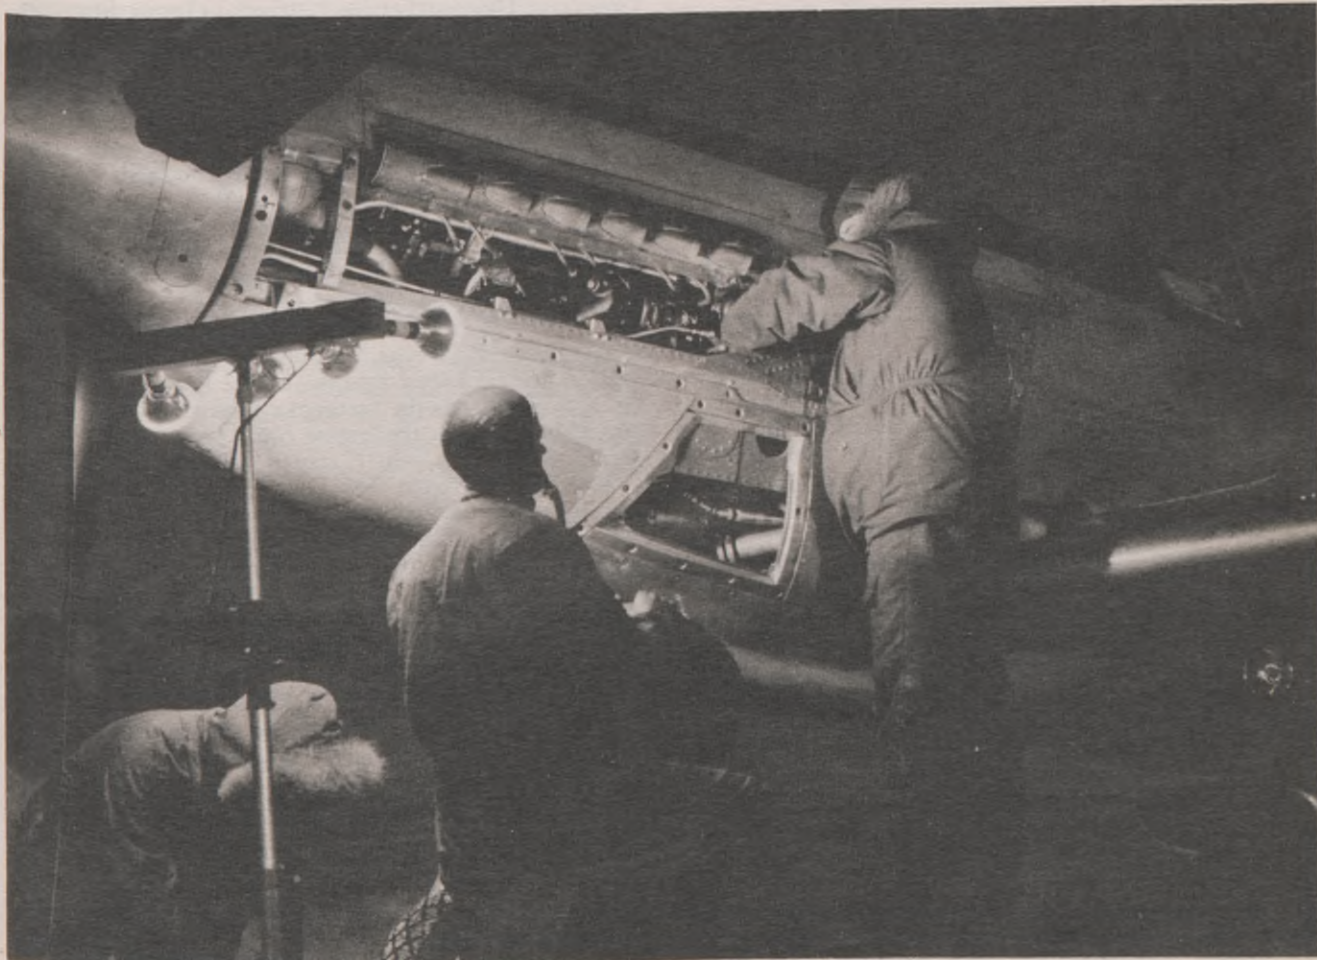
C. CONCLUSIONS

(1) Standard wing covers made of muslin material left much to be desired from the standpoint of ease of placement and removal. They soon became moisture laden and froze stiff, remaining this way the greater part of the season. They had to be thawed out before they could be used and then they were very difficult to remove, having frozen to the wing surfaces.

(2) Standard engine covers were used. The snug fit of the cover made it very difficult to install unless it

was perfectly aligned. Alignment difficulties were aggravated when the cover became soaked with oil or coolant and froze stiff. The zipper type fastener was very unsatisfactory as the packed snow, ice, dirt or congealed oil made it impossible to zip, and the actuating clasp was too small to grasp firmly with gloves on. In the morning, engine covers were often removed before preheat was applied to the engine section because it was easier to preheat without the cover than to match up the heater duct holes. Considering the tight cowling on this type aircraft and the relatively small air space between the engine and the cowling, heat loss was comparatively low and the time period required to adequately preheat was quite short with or without covers. The protection feature of the cover was very good but unnecessary. Some covering for the engine exhaust stacks is considered necessary but it is felt that a stack cover or individual stack plug would suffice.

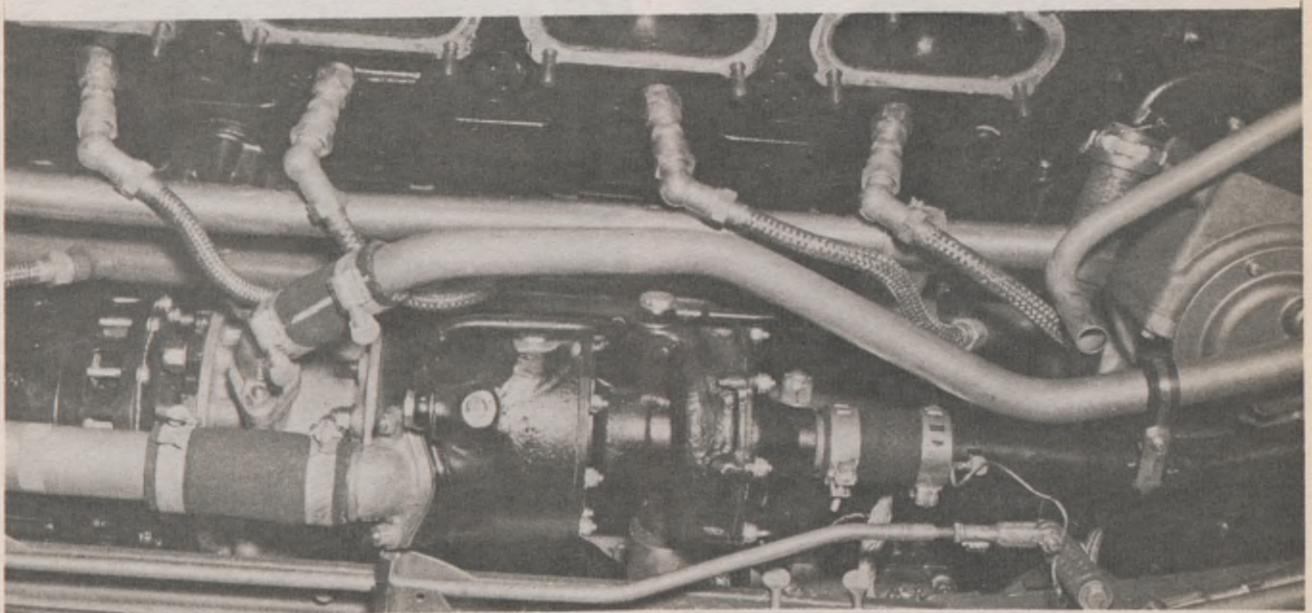
Oil separator, mounted between after cooler and generator on P-51 D

1. It is recommended that the Packard Motor Car Company and the Power Plant Laboratory determine whether or not the installation of this Thompson centrifuge is satisfactory and safe insofar as durability, life and engine operation is concerned.

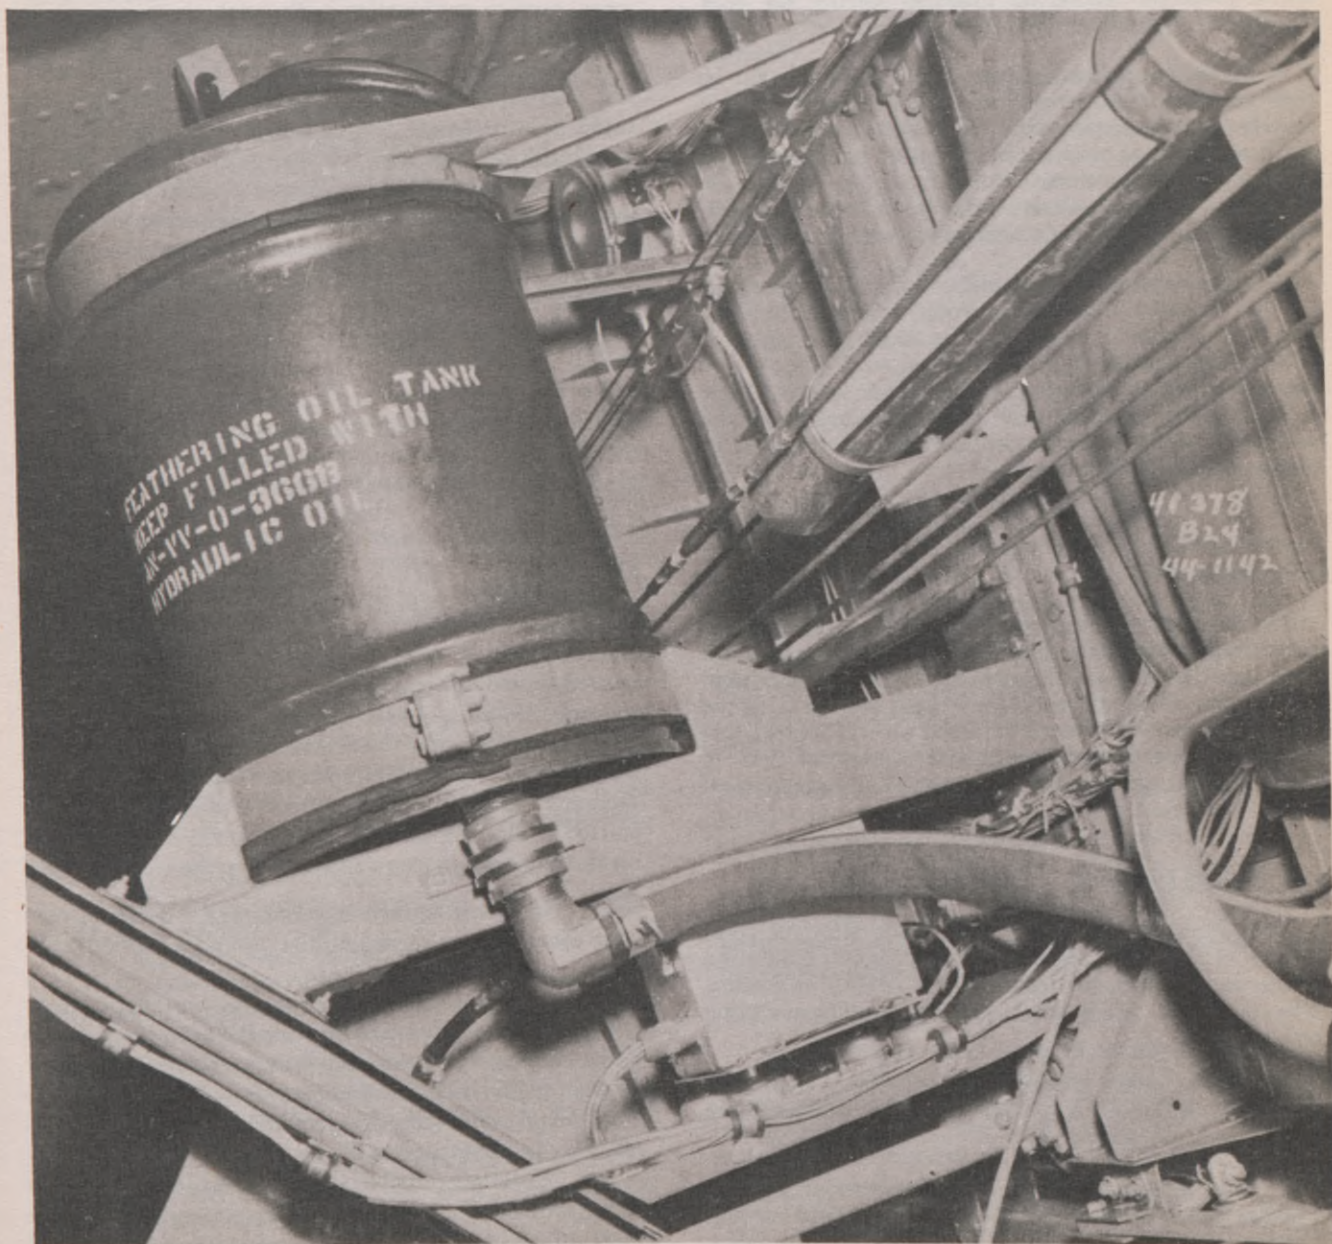
5. The new type Pesco feathering pump, model E-777 operated satisfactorily although it appeared to require more time to complete the feathering operation than the standard Pesco 301 pump. The E-777 pump shows pos-

Hydraulic propeller feathering tank mounted in bomb bay of B-24 airplane

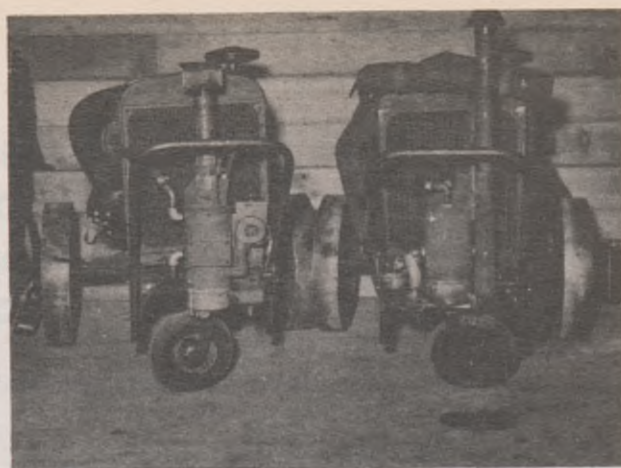
a. The use of external heat for cranking and starting Types C-13 and C-13A A. P. U.'s is necessary at outdoor temperatures below 10°F . A heating system should

Coolant heaters mounted on auxiliary power units

be developed to produce 70 degrees rise in the oil and batteries at $-65^{\circ}\text{F. O. A. T.}$

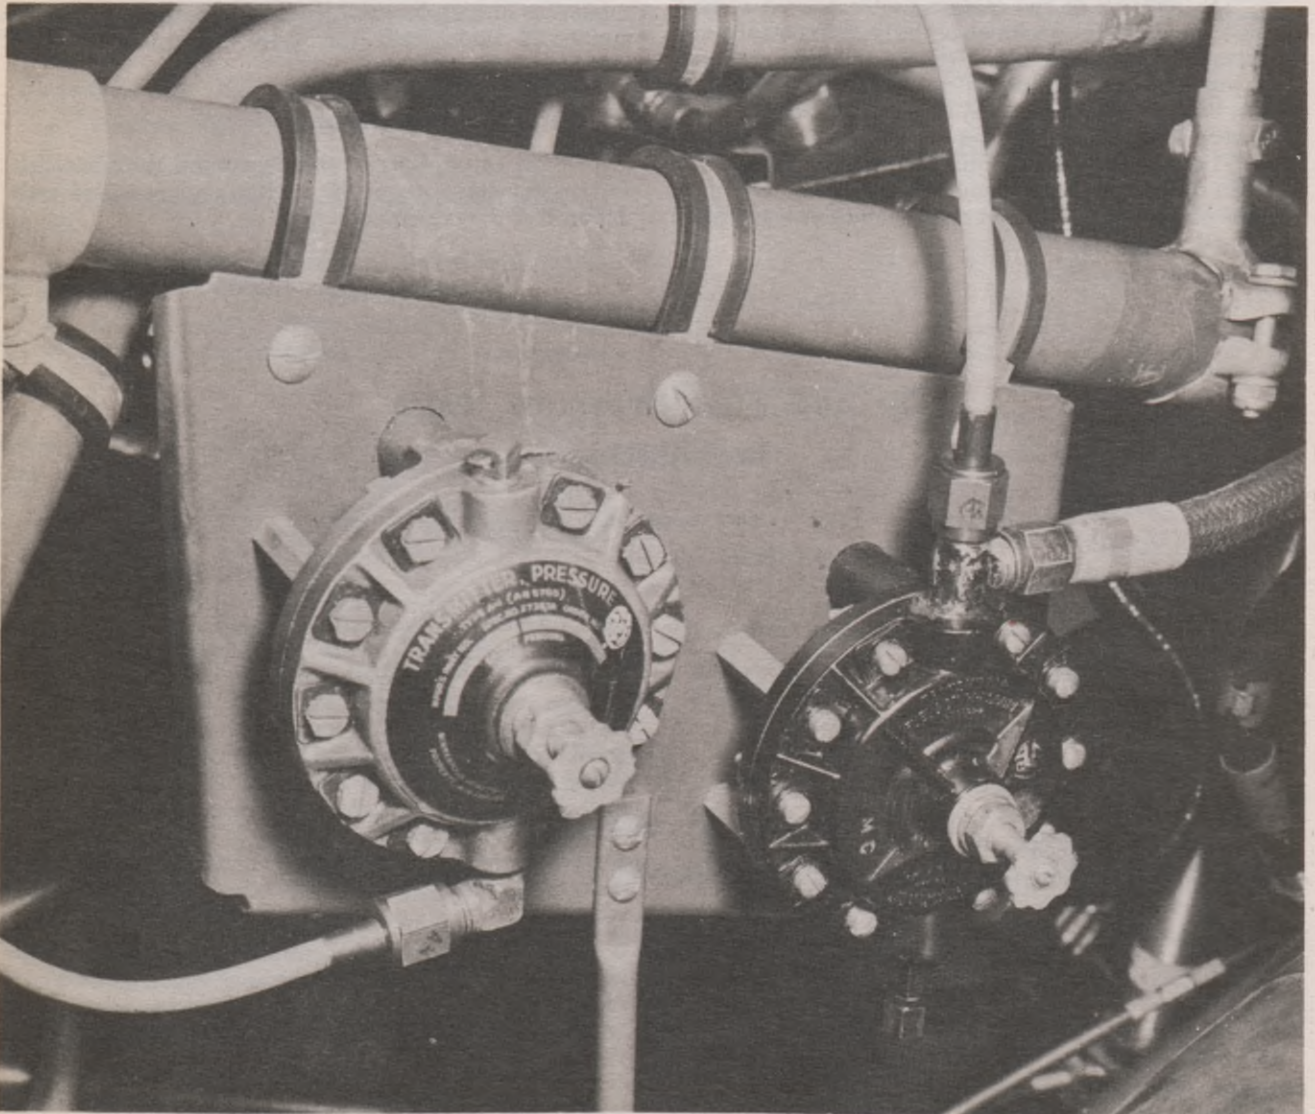
5. P-63 aircraft, being ferried through this base, do not have the panel fitting installed in the cockpit for servicing the oil lines. The indicators are rear mounted and very difficult to remove from the panel for servicing. Consequently, maintenance personnel do not service the lines at the instrument but brake the line in the nose wheel well at an easily accessible connection. This clears the line from this point to the engine, but does not clear the line back to the gage.

A-1 pressure transmitters mounted on left engine support on all engines

1. It is recommended that the modification described in Paragraph B-4 be considered for use in Army Air Forces aircraft for extreme low temperature operation.
2. It is recommended that the comparative advantages and disadvantages of autosyn and A-1 types of oil and fuel pressure gages be reviewed considering the information contained in this report in an effort to standardize one type of remote indicating system for all combat aircraft.

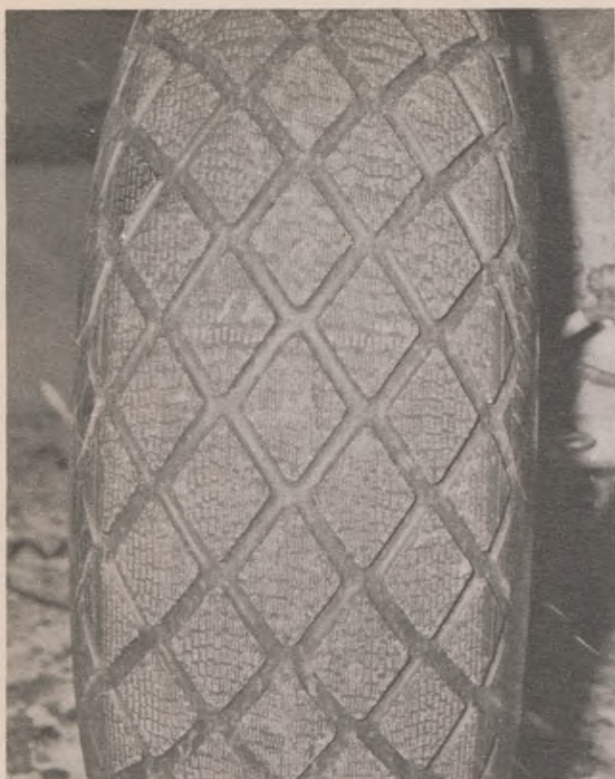
(2) Snow and ice tires. These items of equipment are controversial. Some pilots do not believe they pay for themselves, especially on heavy aircraft. Other pilots claim they would not operate without them. Yet, one engineer, an officer of ETOU, stated that one pilot who was very strongly in favor of these tires did not know that his own airplane was not so equipped. The old "beer bottle cap" style tire has been supplanted by a conventional non-skid type tire with the non-skid elements strengthened and bolstered by small steel inserts. In general, pilots of Cold Weather Test activities did not seem to think that there was enough noticeable increase

Ice grip tire with steel spring inserts

in performance of the snow and ice grip tires on heavy, high performance aircraft to warrant their use. The Aircraft used by the undersigned was equipped with the old "beer bottle cap" style tires. The airplane was light and of low performance, and on glare ice runway, with a very light film of water over the ice, they were a help in taxiing. However, such runways were encountered only three (3) times, twice in Alaska and once at Patterson Field. The only noticeable difference was that a great deal more care had to be exercised in taxiing. Snow and ice grip tires are difficult to manufacture, thereby slowing production, and are more expensive. The mild weather prevailing at Ladd Field during the latter part of January gave excellent opportunities to test these tires, and Cold Weather Test personnel were making every effort to obtain information on this equipment during the mild weather period which caused slippery runways.

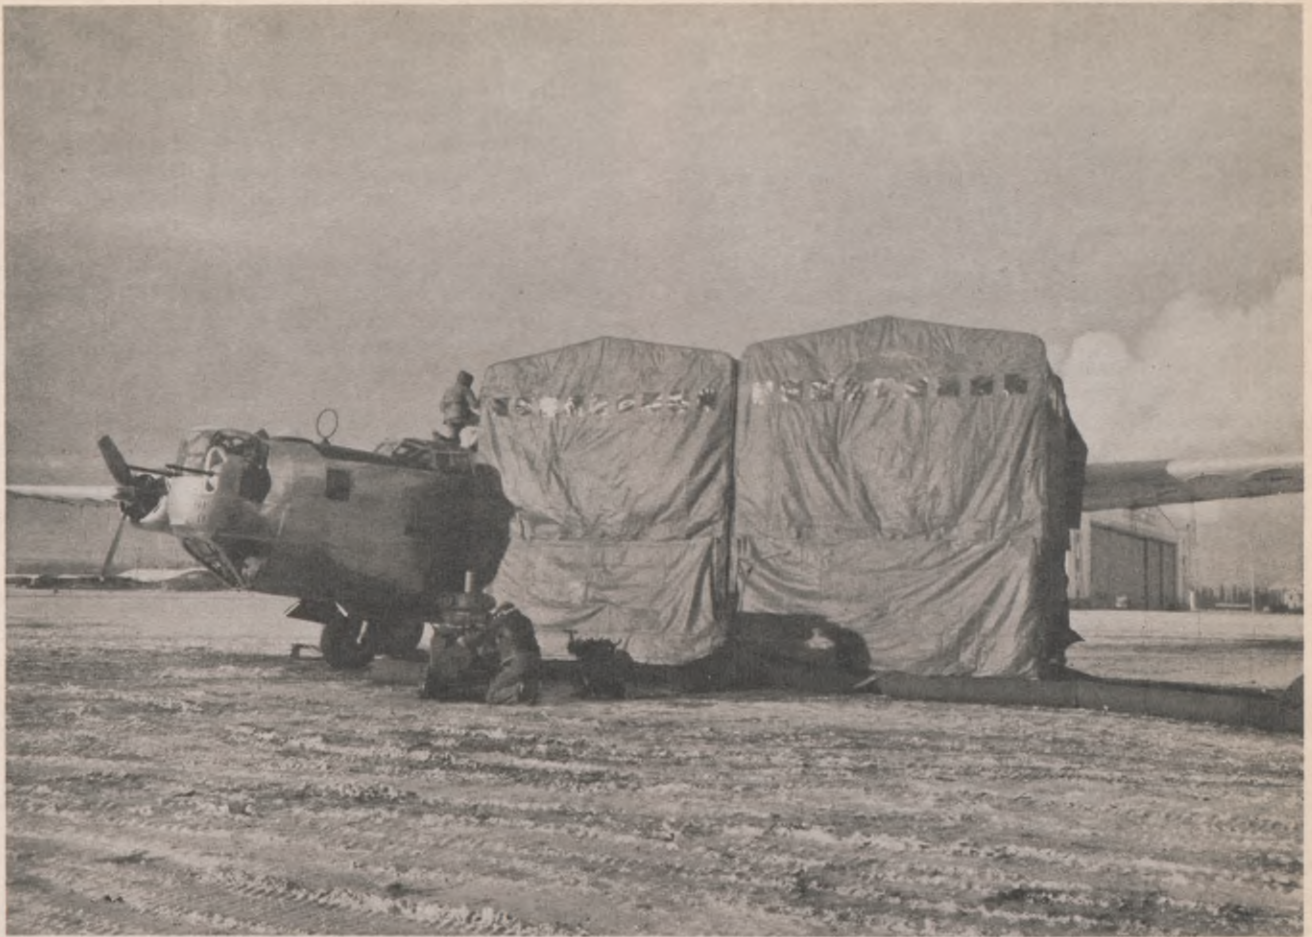
a. Oil hose failures on P-51 aircraft is prevalent during cold mornings. Inspection of the hose in the field disclosed that it was aromatic non-self-sealing hose. In

Maintenance using heated nose hangars

accordance with existing Technical Orders, this type hose is not recommended for oil systems but may be used if the regular hose is not available. For cold weather operation, it is recommended that only specified oil hose be used on these aircraft.
